## **CIVIL RIGHTS COMMISSION AGENDA:**

March 12, 2026

1. Updates from last meeting and commission member feedback.
2. Review of draft 2026 ADA Transition Plan
3. Discussion item as requested by Commission member Holmes.

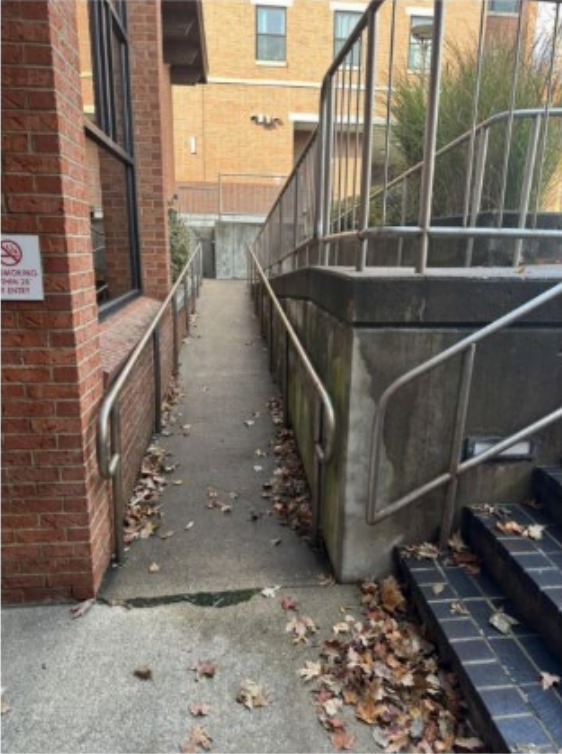
Image 1.3 \*Image shows the ramp, at the entrance with the attached parking lot, with a narrow ramp.

- Install electric door openers for bathroom entrances
- Redesign/widen wheelchair ramp
- Realign entry doors or remodel vestibule

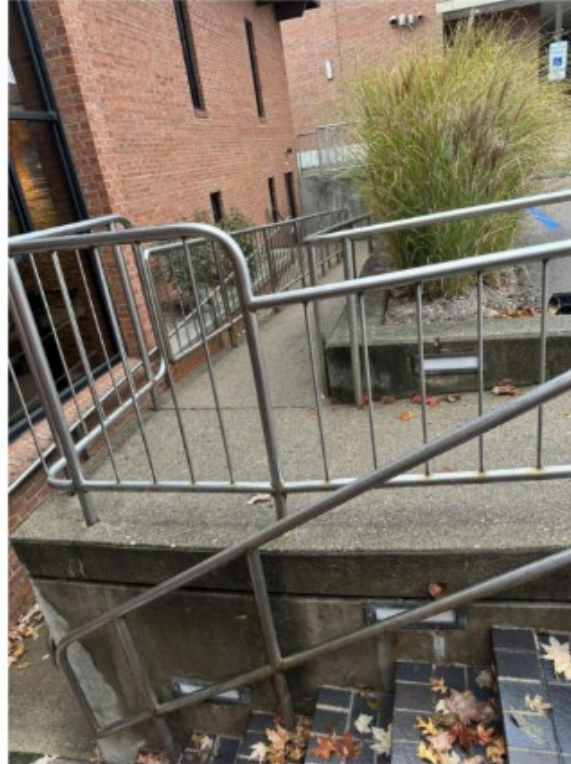
Image 1.4 \*Image shows the ramp, at the entrance with the attached parking lot, with a ramp that has several narrow turns.

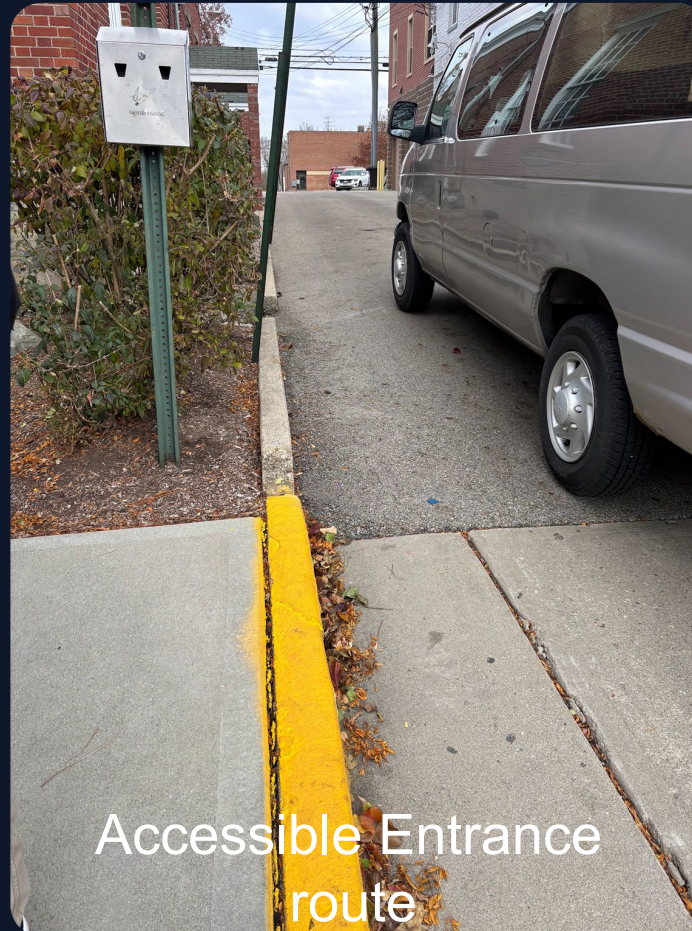
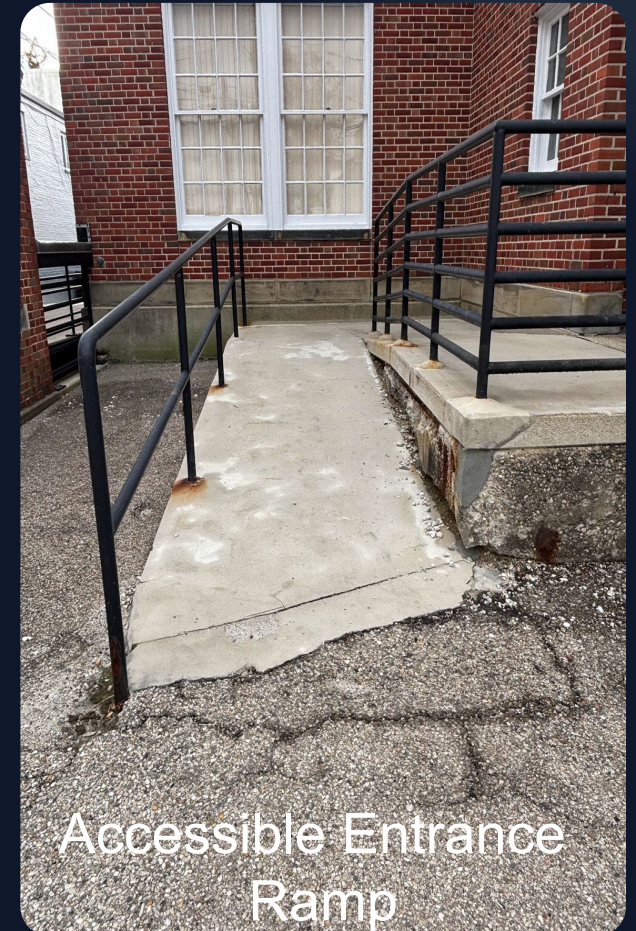
1. Ramp entrance at the front of the building
2. Official signage inside the building
3. Van accessible parking
4. Powered doors throughout the building

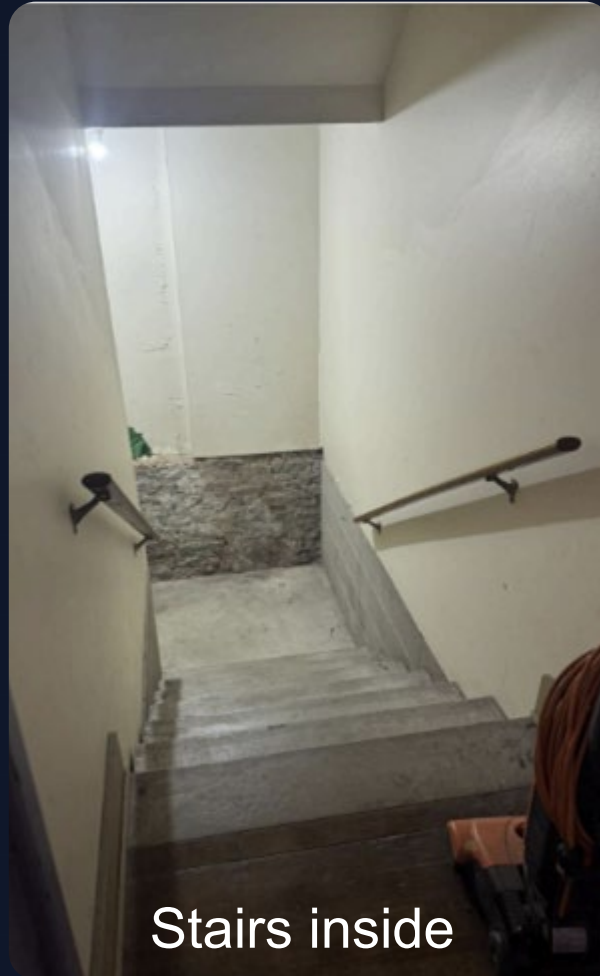
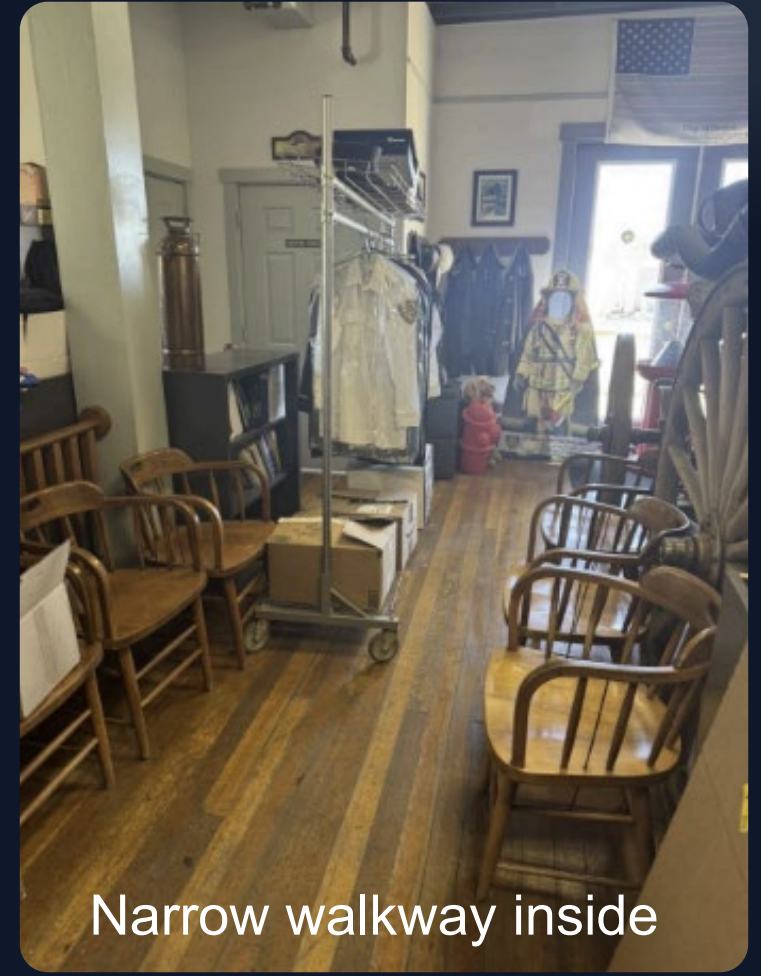
1. Adding accessible parking spaces
2. Declutter walkways to make them more accessible
3. Adding accessible bathrooms
4. Leveling out the ground to remove tripping hazards
5. Add an elevator

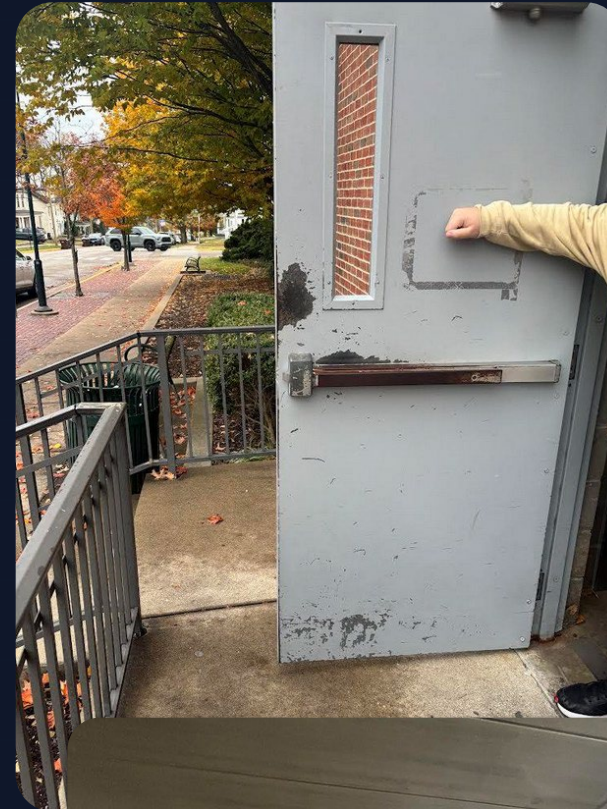
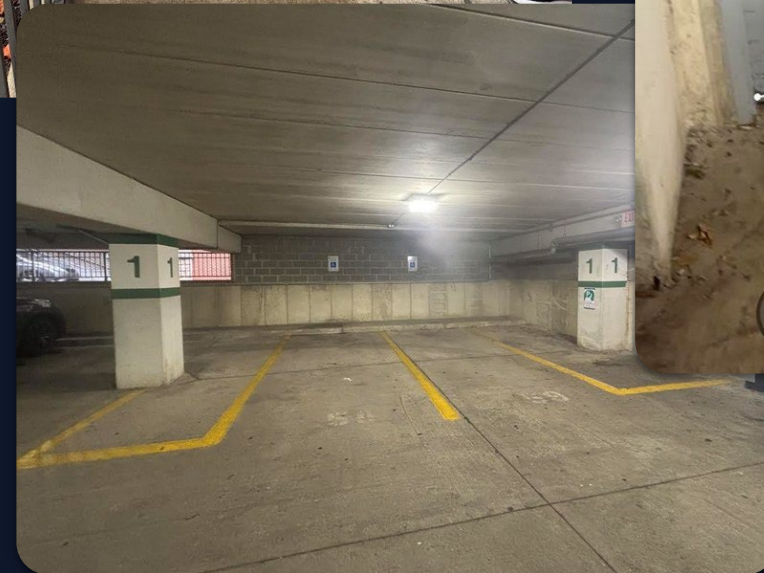
1. No ‘truly’ accessible entrances - the only open - air exit ramp is rather steep
2. No aisle next to accessible parking spots (aisle should be at least 5 ft wide).
3. Add some van accessible spaces (not the same as general accessible spaces since these are wider - at least 8 ft wide)
4. clearly mark accessible spots with high - contrast paint such as yellow to discourage misuse
5. Add some ‘Van Accessible’ signs

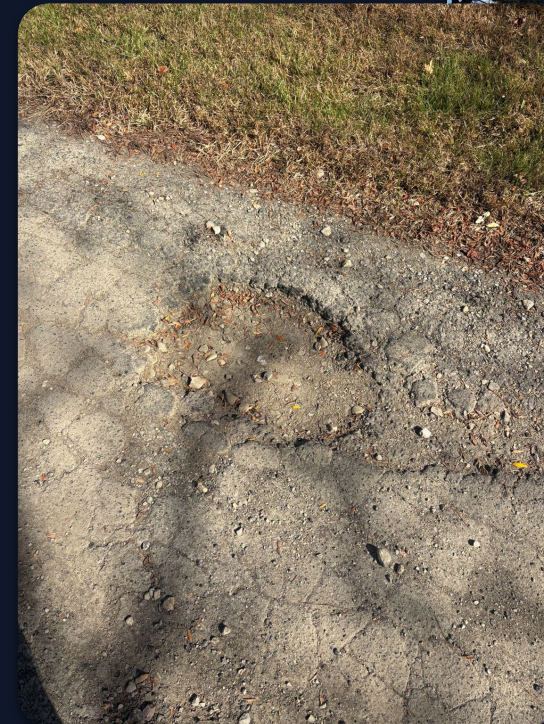
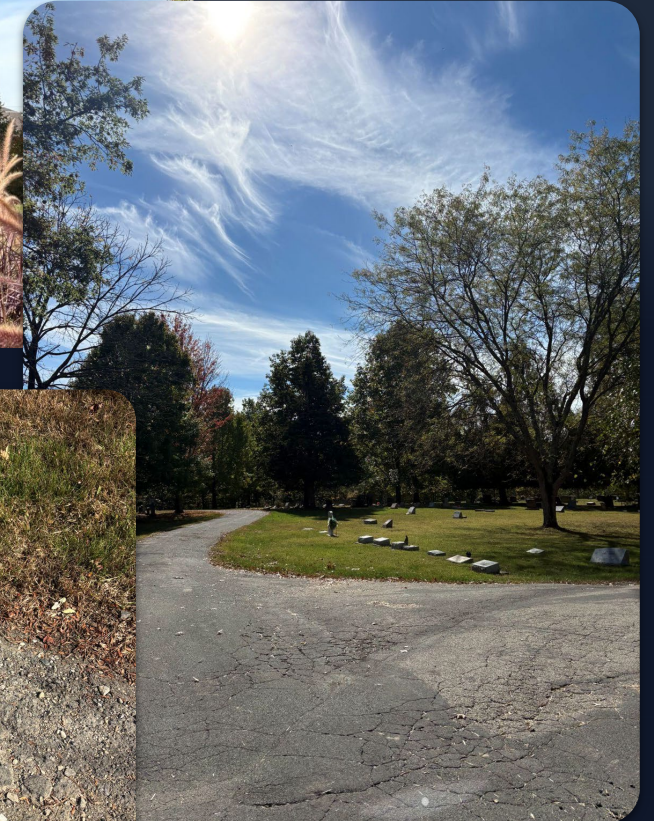
1. No parking lot - all street parking
2. The ground is paved - but many uneven areas
3. The cemetery is kind of hilly - if a tombstone is farther down the hill it will be very difficult for a wheelchair user to access It
4. Not much signage - no way to tell where you were or to find a tombstone. Add Braille.

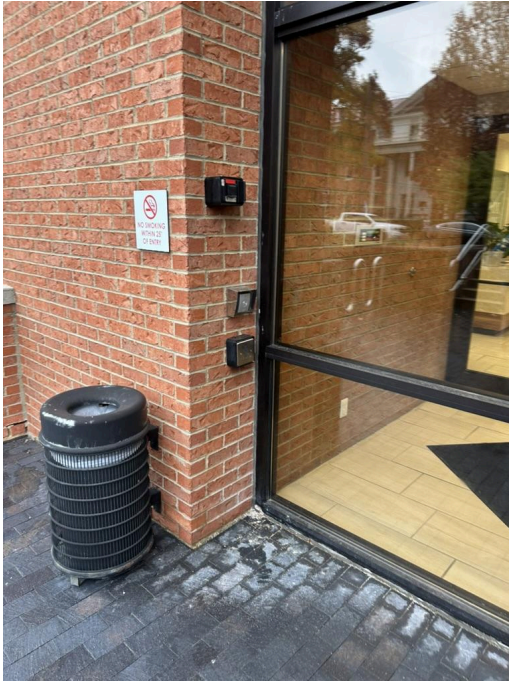
- At the same entrance, the accessibility button to open the door is far on the other side of the door frame. **See image 1.1.**
- The entrance on S. College Avenue has brick pavers, when wet this can be hazardous to walk on for community members. The day this audit was taken it was raining and the pavers seemed slippery. **See image 1.2.**

Image 1.1 \*Image shows the automatic door opener on the opposite side of the entrance to which the door is located.

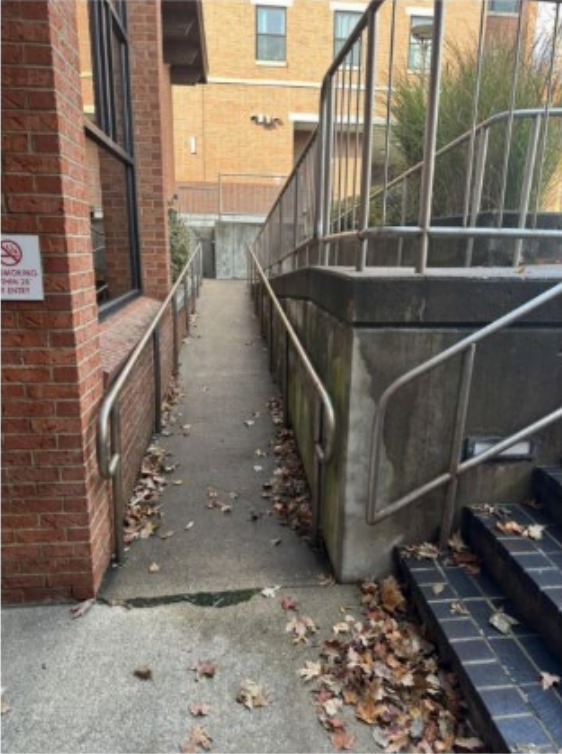
Image 1.3 \*Image shows the ramp, at the entrance with the attached parking lot, with a narrow ramp.

- Install electric door openers for bathroom entrances
- Redesign/widen wheelchair ramp
- Realign entry doors or remodel vestibule

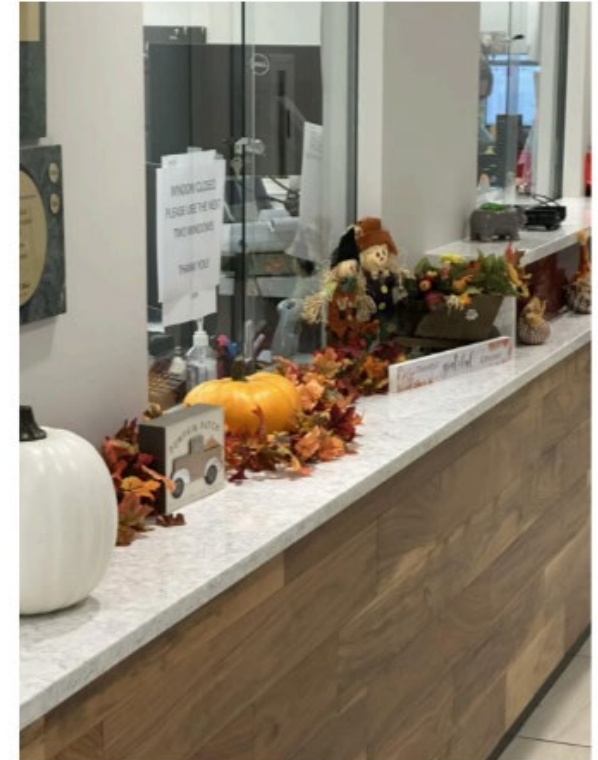
Image 2.3 \*Sign says: WINDOW  
CLOSED PLEASE USE THE NEXT TWO  
WINDOWS THANK YOU!
