CIVIL RIGHTS COMMISSION AGENDA:

June 11, 2026

1. Presentation — Student Group Conducting the Accessibility Study for the City.

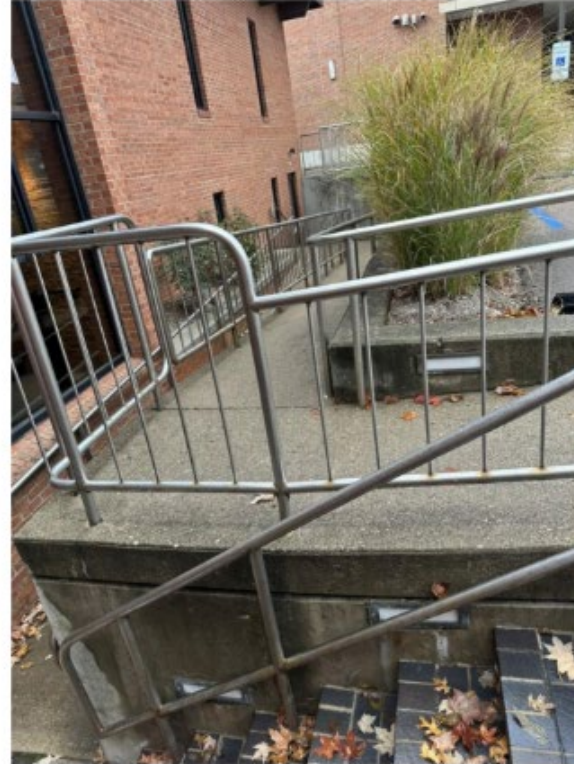
Image 1.4 *Image shows the ramp, at the entrance with the attached parking lot, with a ramp that has several narrow turns.

- Install electric door openers for bathroom entrances
- Redesign/widen wheelchair ramp
- Realign entry doors or remodel vestibule

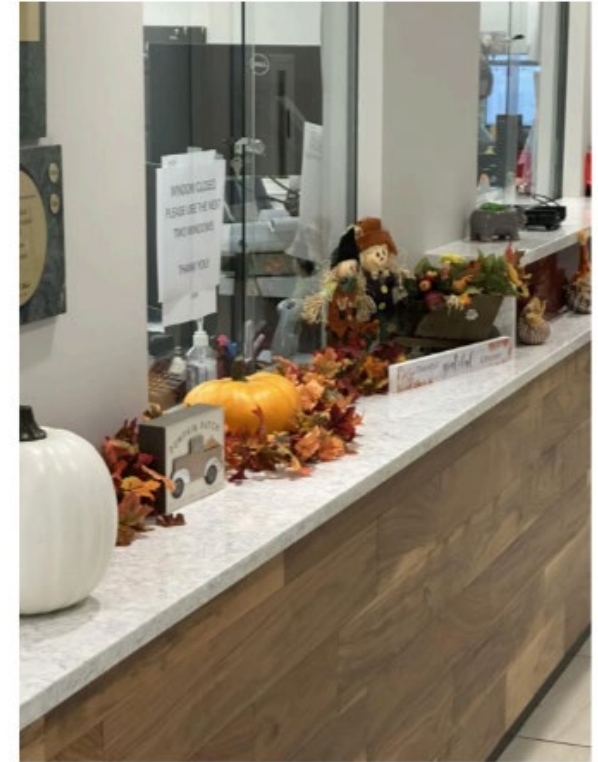
Image 2.3 *Sign says: WINDOW
CLOSED PLEASE USE THE NEXT TWO
WINDOWS THANK YOU!

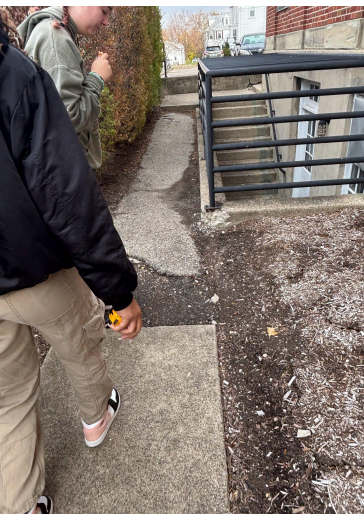
Uneven sidewalk on the side of the building closest to the curb cut. This makes it difficult or impossible for disabled people to access the accessible entrance from this side.

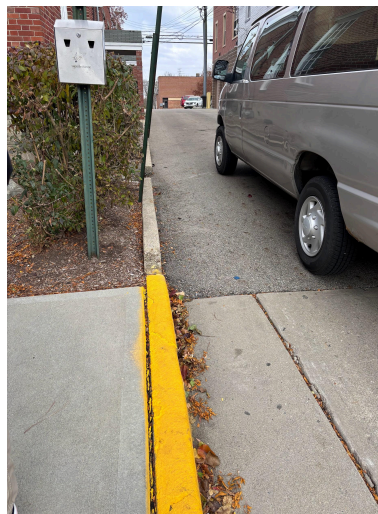
Accessible entrance on the other side of the building that is blocked by a van, making it narrow. This makes it difficult for wheelchair users, those with mobility aids, or service dogs to navigate to the accessible entrance.

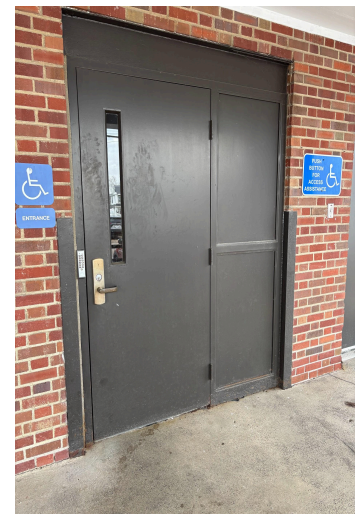
Accessible door in the back of the building. The door can only be opened by the staff from the inside.

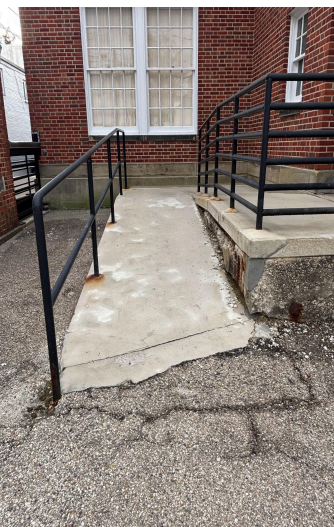
Uneven ramp that is covered in rocks and pebbles, making a difficult transition from the road. Additionally, the ramp is only wide enough for one person at a time, meaning people would have to walk in a line rather than next to each other.

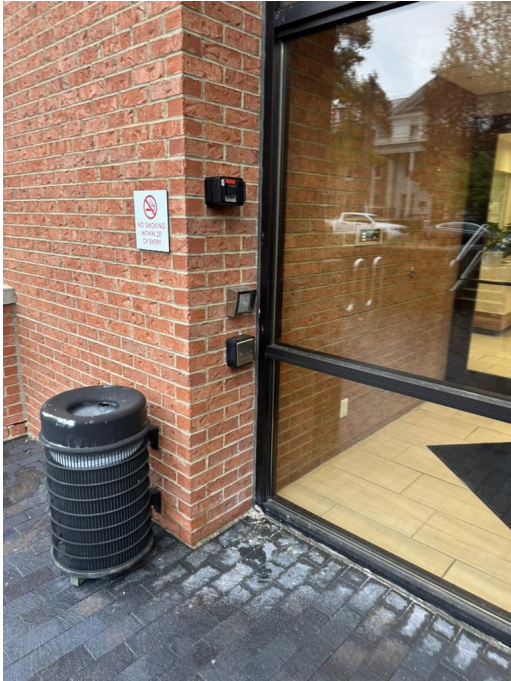
- At the same entrance, the accessibility button to open the door is far on the other side of the door frame. **See image 1.1.**
- The entrance on S. College Avenue has brick pavers, when wet this can be hazardous to walk on for community members. The day this audit was taken it was raining and the pavers seemed slippery. **See image 1.2.**

Image 1.1 *Image shows the automatic door opener on the opposite side of the entrance to which the door is located.

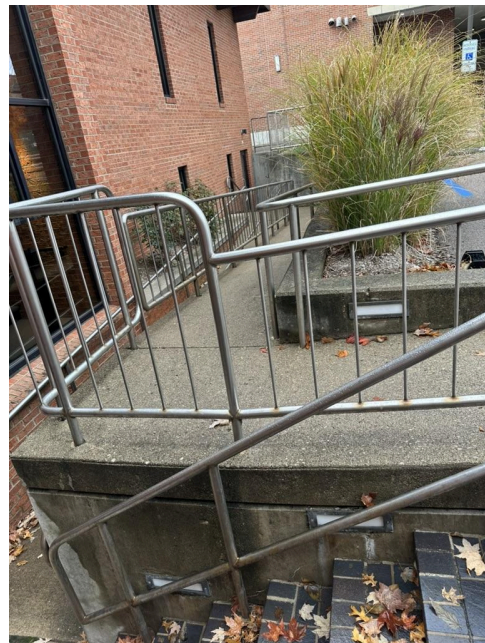
- At the entrance on the side of the building with the attached parking lot, the wheelchair accessible ramp is very narrow and there are a lot of turns to get to the entrance door to the municipal building. This only allows for one directional usage of the ramp at one time. Due to the many turns in the ramp it makes it difficult for community members in wheelchairs to efficiently get to the building with low effort. **See images 1.3 and 1.4.**

Image 1.3 *Image shows the ramp, at the entrance with the attached parking lot, with a narrow ramp.

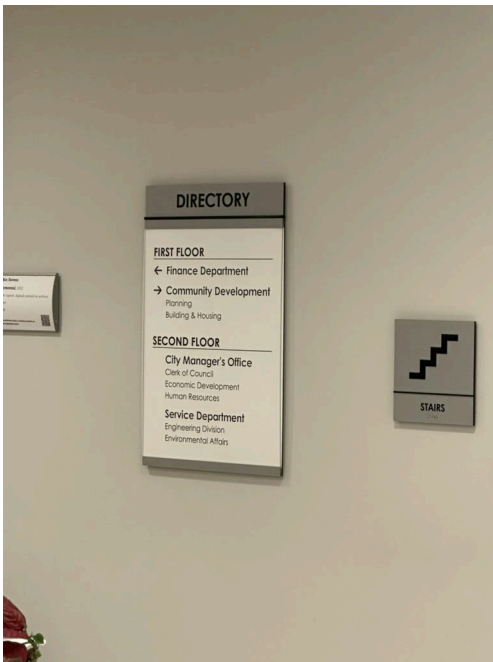
- Add an additional directory that is closer to the entrance on S. College Avenue. Currently there is one on a plastic stand however it is small and hard to read for people with visual impairments. All directories should also include braille for visual accessibility for all community members. **See image 2.1 and 2.2.**

Image 2.1 *Image shows a small directory more difficult to read.

- b. Adding accessible soap dispensers by the sinks and a coat hook inside the handicap stall, in the bathrooms.
- c. Add braille to the directories.
- d. Replace the brick paved walkway on the side of S. College Avenue. This might be costly but both entrances currently have slippery walk ways that can make it hazardous for people to walk on. The other entrance to the building, with the attached parking, might be more expensive to replace because the ramp is hardly accessible and the steps have brick pavers. Therefore, it would be easier to just redo the one side where the wheel chair access is already up to accessibility standards and the steps are only concrete, not brick.

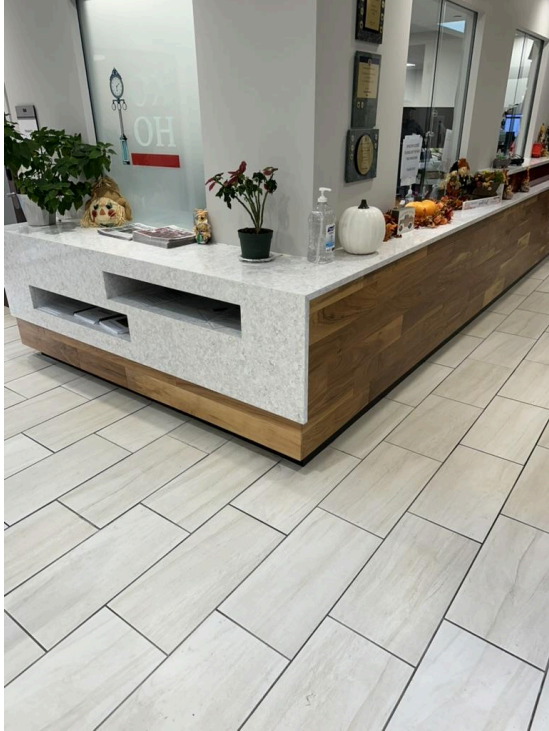
- The Help Desk on the first floor doesn't have a hanging style counter top where community members in wheelchairs or with walkers can comfortably go up to the counter as their legs will hit the wall. Also, at the time of the audit, the Help Desk that is lower compared to the additional windows adjacent to was closed. This makes it more difficult for disabled community members in wheelchairs or with growth stunts to easily communicate to the workers behind the glass. A recommendation would be to always have the window that is lower to the ground open rather than the other two windows that are raised in height. **See image 2.3 and 2.4.**

Image 2.4 *Image shows that there is no overhang on the countertop ledge.

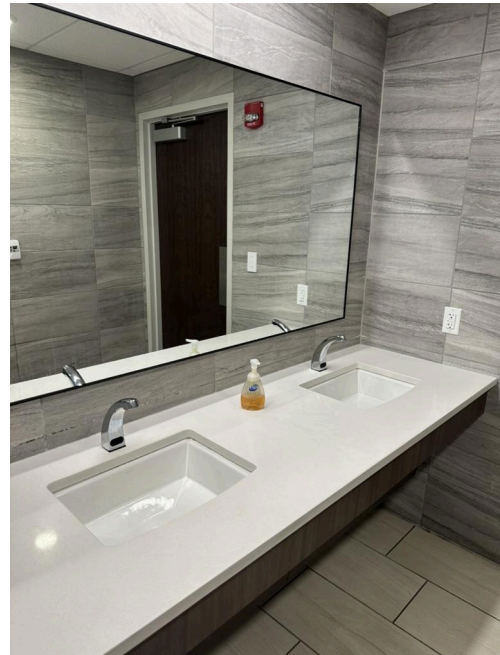
- In the bathroom, mens bathroom specifically, there is no hook for a jacket or backpack in the handicapped stall. Typically found on the door that opens and closes. **See image 3.2.**
- The soap in the bathroom, men's specifically, isn't mounted to the wall. With it being a free standing and movable item, it can be pushed too far back for some community members to reach. A recommendation would be to put a soap dispenser mounted on the wall at a reasonable height and close distance to the sinks. **See image 3.3.**

Image 3.2 *Image shows no coat and backpack hanger on the stall door.

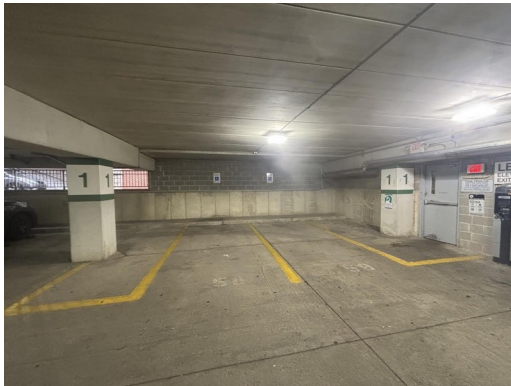
To start our assessment, we used the 'Entrance' criteria to assess the parking lot. The first thing we found that did not meet ADA standards was that, although the accessible spaces were over 8 feet wide, there was no adequate access aisle on either side of the space. The ADA requires an access aisle to be at least 5 feet wide, and the ones in the parking garage do not meet this requirement. To remedy this problem, Xander and I suggest that the City Council reconfigure the accessibility spaces so that the middle of the two spaces can share an aisle at least 5 feet wide. This will comply with ADA standards, as two spaces can share an access aisle. The second problem we found with the entrance that did not meet the standards was that the van-accessible spaces (which were the same as the normal accessibility spaces) did not have adequate aisle widths. To fix this problem, we suggest removing some spaces to create a designated van-accessible space that meets the required standards: 8 feet wide with an 8-foot aisle, or 11 feet wide with a 5-foot aisle. The third problem we found in the parking garage was that the access aisles were not painted to discourage parking in them. This is a very easy fix: all the city council

has to do is paint the aisle in a high-contrast color, most likely yellow, to comply with the ADA. Another problem we found at the parking garage was that there were no 'Van Accessible' signs in front of the accessible parking spaces. To comply with the ADA, the Oxford City Council must install signs at the new van-accessible spot recommended above.

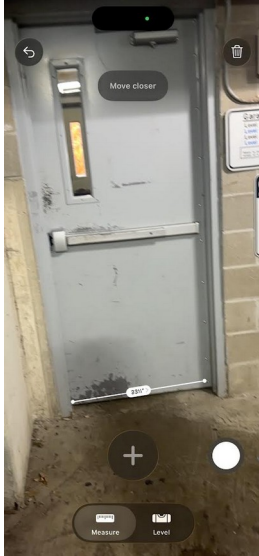
We then used the 'Entrance' criterion to assess the entry to the area with the elevator and door to the outside. The first problem we discovered was that the door to the vestibule containing the elevator and exit to the outside was not 36 inches wide and had no power door. This would make it almost impossible for someone who uses a wheelchair to navigate from the parking garage to the elevator and to the outside. Xander and I's solution to this would be to replace the door so it has power and can be opened by a button, and make it at least 36 inches wide instead of the 33 and a half inches it is now. Another problem we found with the entrance/exit of the parking garage was that the handrails on the ramp do not extend 12 inches horizontally beyond the top and bottom of the ramp. To fix this compliance issue, the city should install a new handrail that extends past the end of the ramp and adds on to the current handrail to ensure it is up to code.

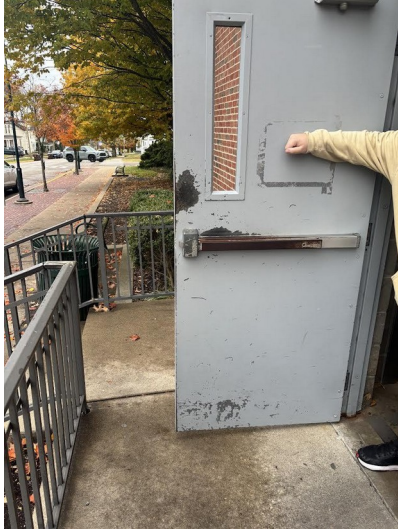
One of the biggest issues we found, and the one that should take priority over all other issues, is that not only is the main entrance not accessible, but no entrances are accessible. While there is room for a wheelchair to use the open-air exit, the ramp leading up to the accessible spaces is too steep to safely navigate in a wheelchair. This is a huge issue that needs to be addressed immediately. To start, the city council should replace the door with a power door that opens with a button press. Moreover, they should consider installing accessible ground-level spots so disabled people can reach exits farther from the main entrance without risking injury while navigating the steep ramps inside the garage. Another slight issue we found was the fact that when the door is open it blocks nearly the entire ramp and only has about a foot in between from the rail which can cause traffic issues and cause some people to not be able to fit through the space.

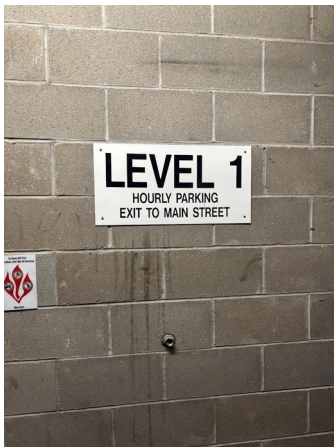
Since the parking garage lacks amenities such as toilets and other common features found in other public spaces, or because the use of the other checklists was limited. However, we did have some findings. To start, many signs in the parking garage lacked braille. For example, the floor-level sign indicating which floor you were on lacked braille. To fix this, we suggest replacing all signs that lack braille with new ones that are accessible to all people. Moreover, we found that the elevator's exterior lights are not high-contrast, which will cause problems for people with color blindness and/or poor vision. To fix this, the city council should replace the elevator lights so that the floor number is clearly visible to everyone.

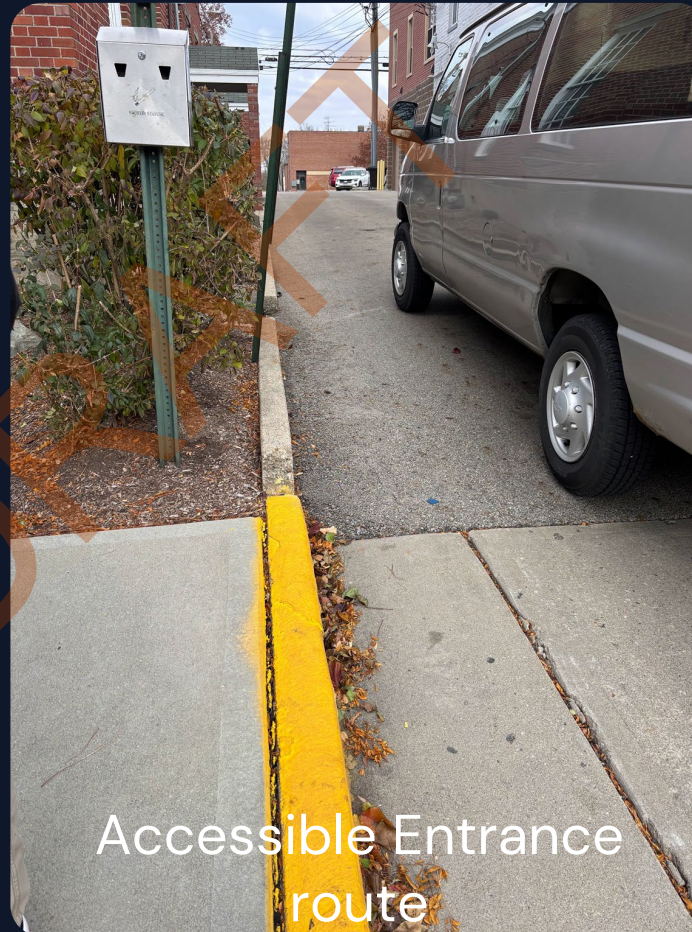
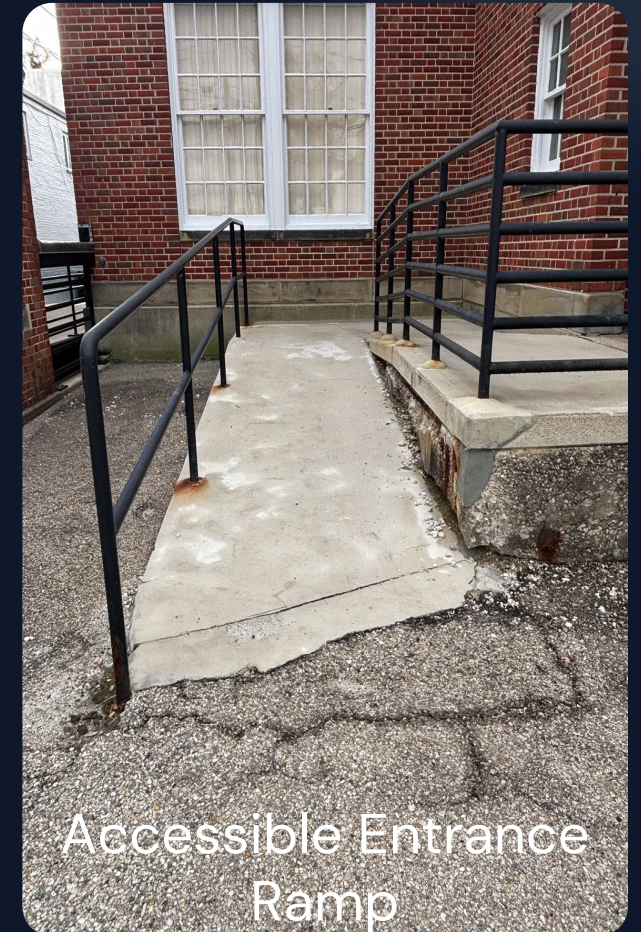
1. Ramp entrance at the front of the building
2. Official signage inside the building
3. Van accessible parking
4. Powered doors throughout the building

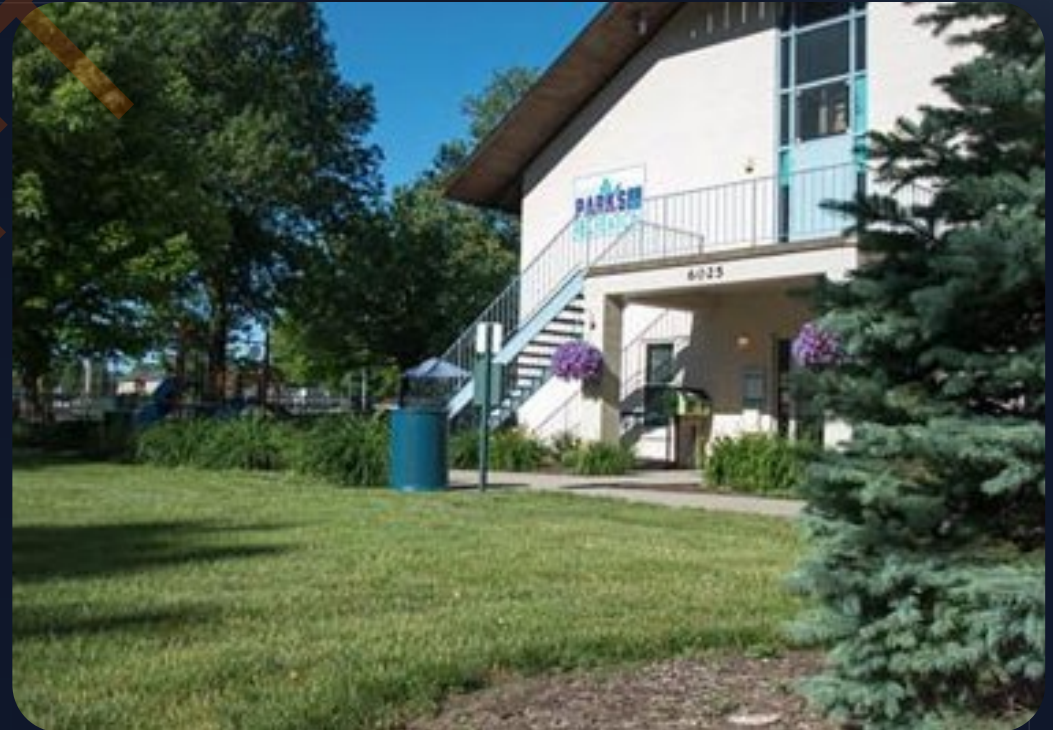
TriCommunity Center

- Add braille signage & clarify signage for accessible entry
- Install fire alarms
- Replace current door with a wider ADA compliant one

- Install insulation/cover over exposed sink pipes
- Fix uneven ramp landing
- Install an elevator to reach the upper floor (only ramp is outside)

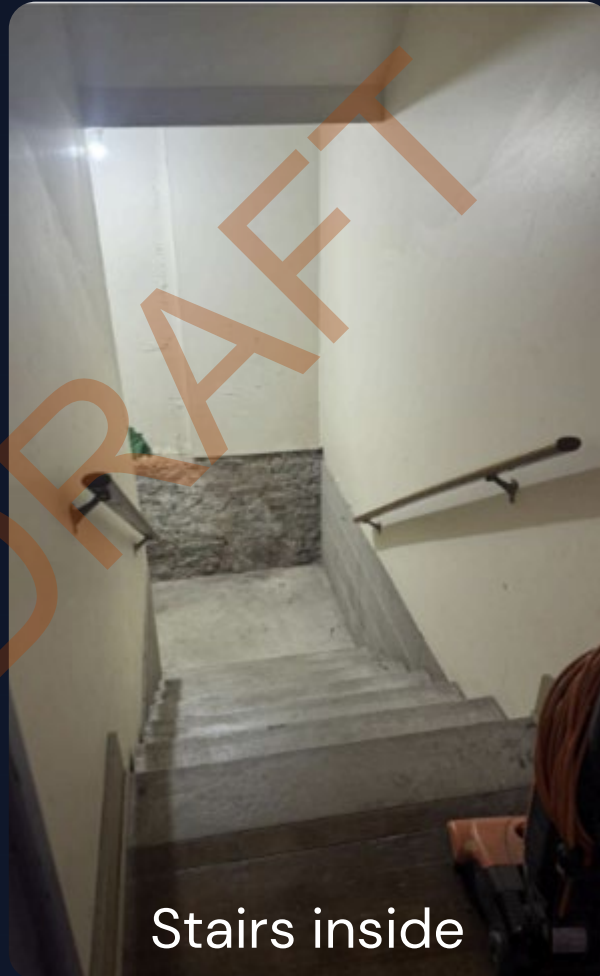
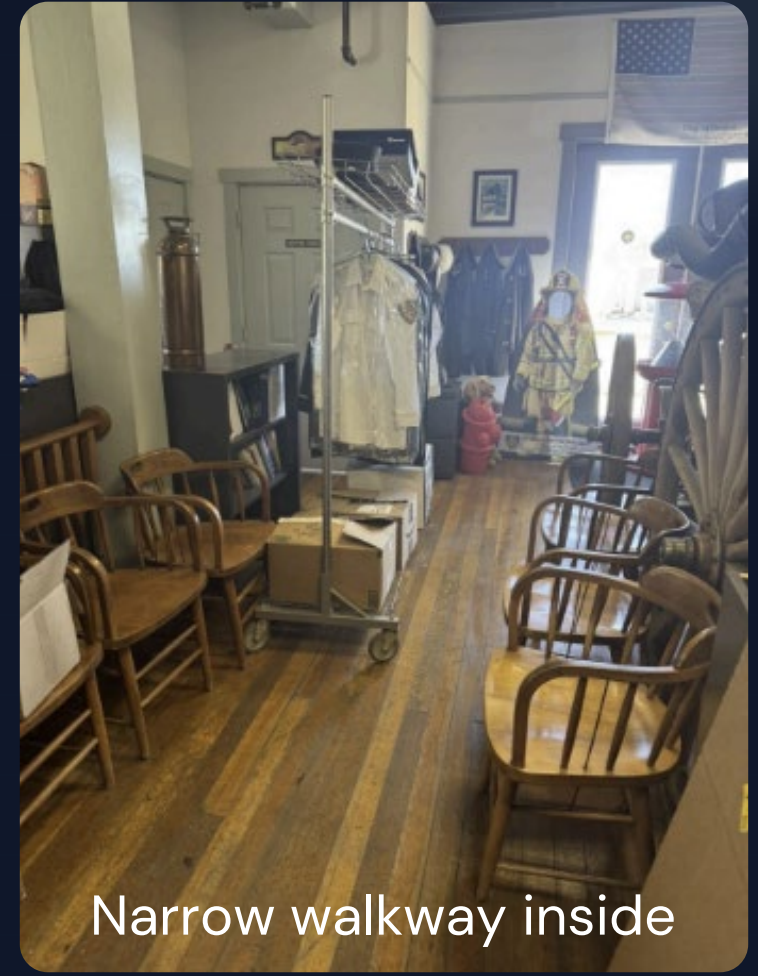
Fire Department

1. Adding accessible parking spaces
2. Declutter walkways to make them more accessible
3. Adding accessible bathrooms
4. Leveling out the ground to remove tripping hazards
5. Add an elevator

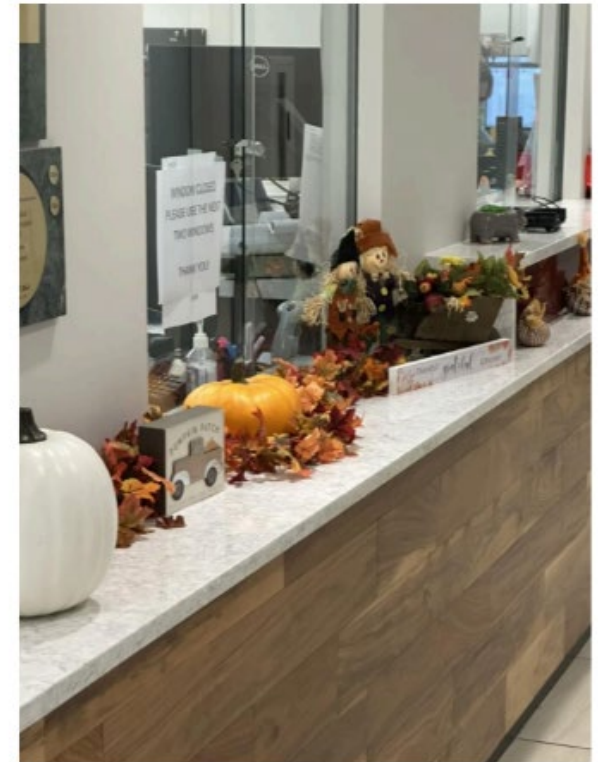
Image 2.3 *Sign says: WINDOW
CLOSED PLEASE USE THE NEXT TWO
WINDOWS THANK YOU!

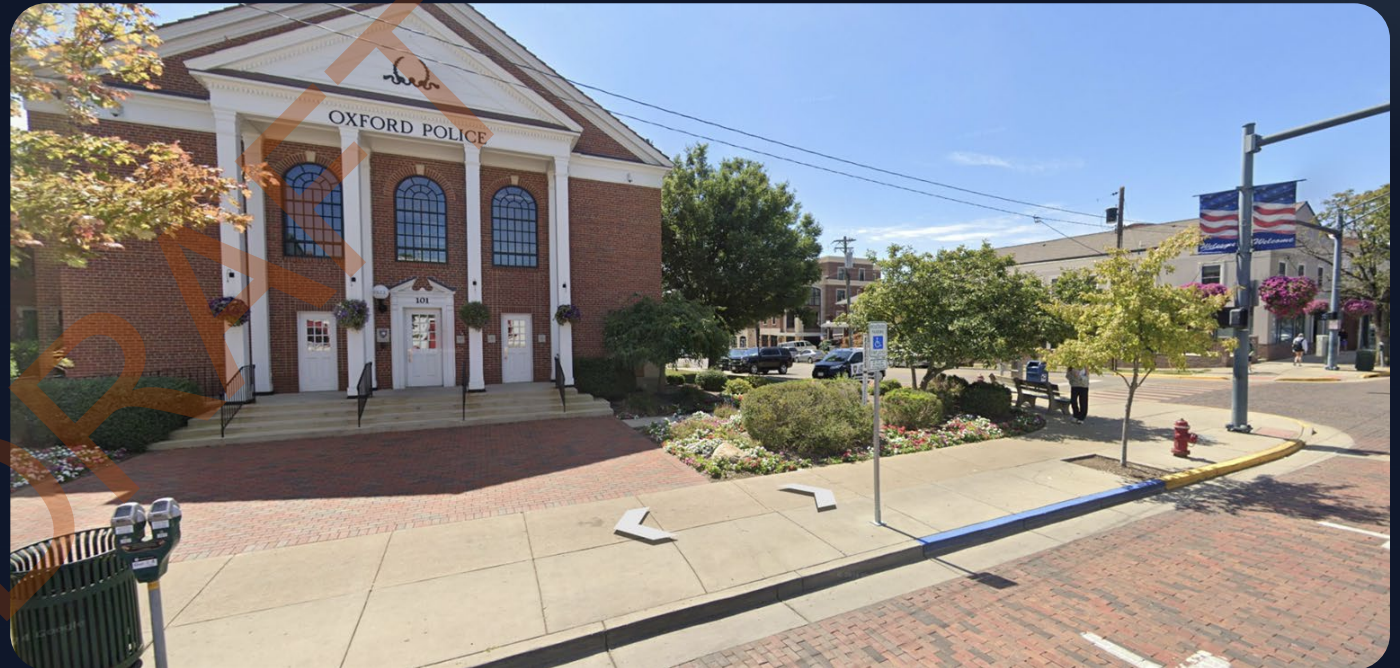
Municipal Building

1. Create a van-accessible parking space in the lot to the left of the building
1. Install a ramp next to the existing accessible parking space
1. Install a power-operated bathroom door
 - a. Foot button for increased accessibility
2. Remove lobby bench and replace with chairs to allow flexibility for a wheelchair space

- a. No – the door is very heavy and does not have a power button
 - i. Recommendation: Install a power-operated door with a button.
Could also install a foot button for increased accessibility.
- 4. Are there an adequate number of wheelchair spaces provided?
 - a. No – ADA requires that for every 4 to 25 seats, one wheelchair space be provided
 - b. There were four seats and no wheelchairs accessible spaces
 - i. Recommendation: Remove the existing bench and replace it with chairs. This allows flexibility and the opportunity for a wheelchair space.

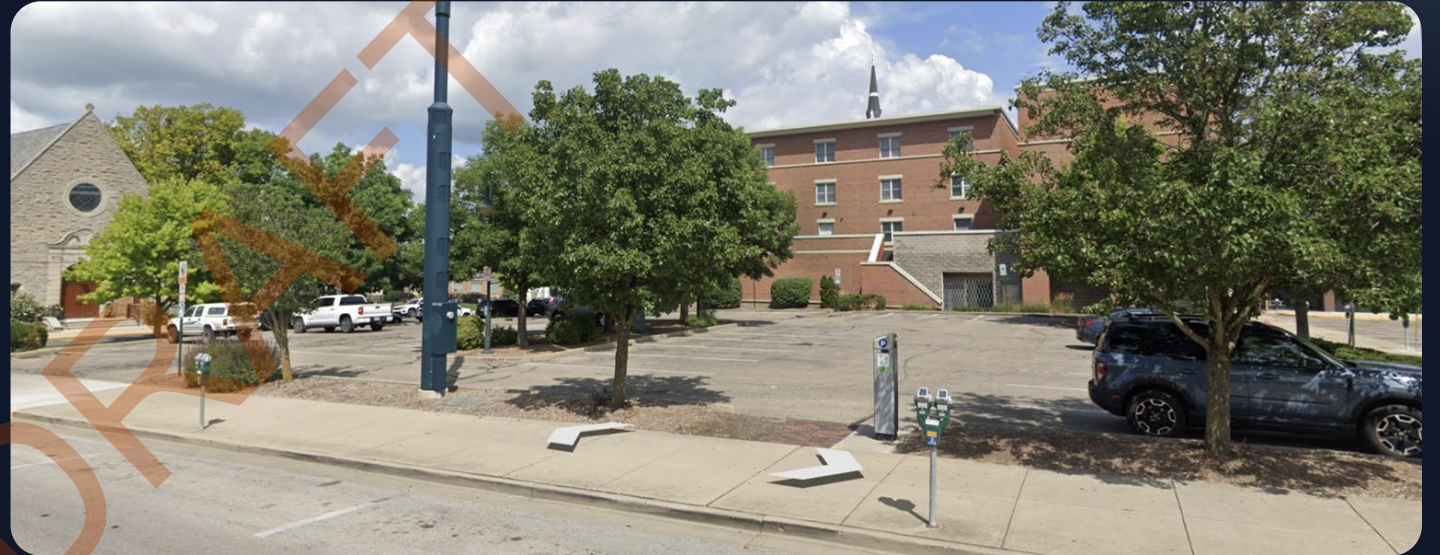
Uptown Parking Lot

Visiting the parking lot, we immediately noticed the lack of accessible parking spots. There are no labelled parking spots for those who are handicapped, which is unusual due to the number of restaurants the parking lot serves. Additionally, the parking spaces are too narrow, potentially causing parking issues for wheelchair users. The parking lot also has broken and uneven pavement, leading to accessibility issues.

- Faded or hard-to-read signs
- Not enough accessible parking spaces for the total number of parking spaces
- Potholes and loose gravel
- Too steep curb ramps
- Parking meters are hard to access for wheelchair-bound individuals

1. Add at least one van-accessible parking space**
2. Add accessible parking spaces closer to entrances of nearby buildings**
3. Crosswalks between accessible spaces
4. Create curb cuts for mobility-aid users
5. Redo pavement

We believe that the priority is to add an accessible van space, and the second priority is to add accessible parking spaces to the nearest entrances/exits. After that, Oxford needs to add curb cuts and crosswalks and redo the pavement. All of these suggestions can be done at one time, so the parking lot isn't closed down for too long. Disabled people have been going on for too long using this inaccessible and dangerous parking lot. Oxford claimed they were going to fix it four years ago and failed. It is time to fix the parking lot.

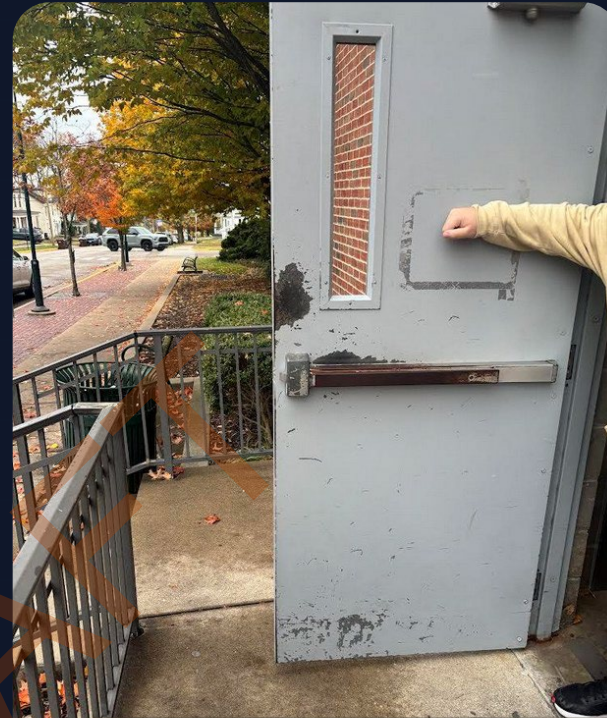
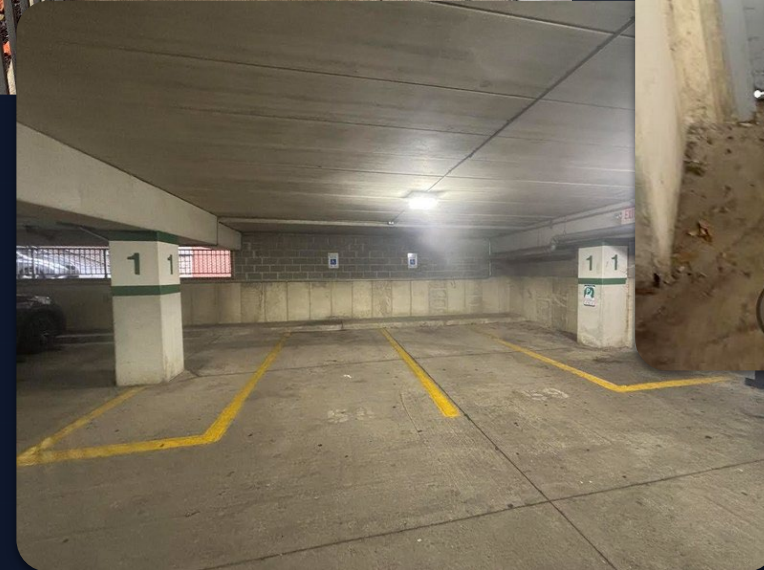
Uptown Parking Garage

1. No ‘truly’ accessible entrances – the only open-air exit ramp is rather steep
2. No aisle next to accessible parking spots (aisle should be at least 5 ft wide).
3. Add some van accessible spaces (not the same as general accessible spaces since these are wider – at least 8 ft wide)
4. clearly mark accessible spots with high-contrast paint such as yellow to discourage misuse
5. Add some ‘Van Accessible’ signs

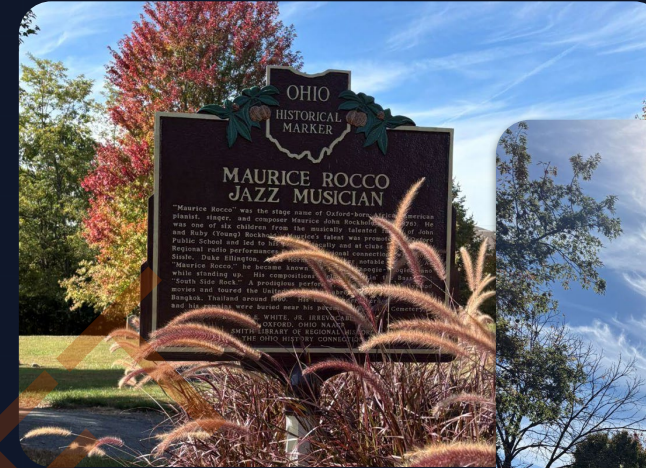
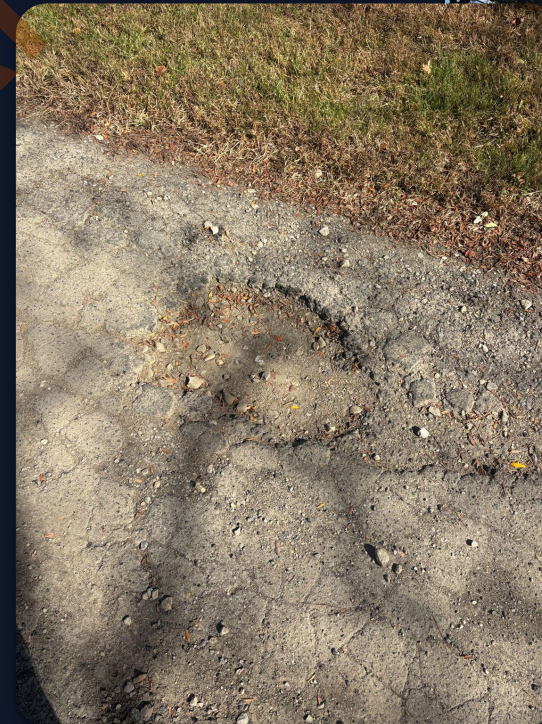
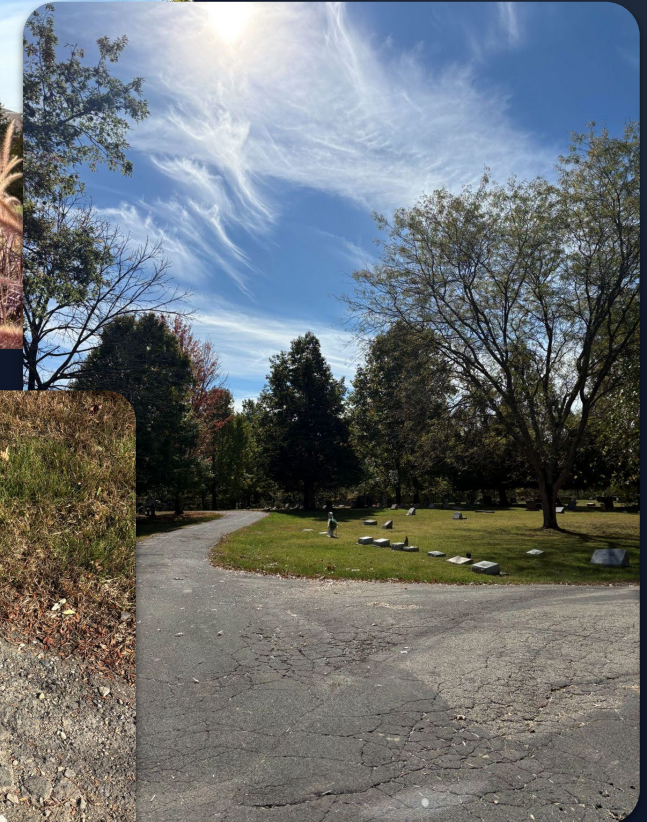
Woodside Cemetery

- b. Missing braille on signs.
 - c. Uneven pavement.
 - d. No restrooms.
 - e. Missing ramps for existing structures (flag pole platform).
 - f. Missing passing space that is no less than 60x60 inches on the sidewalk.

1. No parking lot – all street parking
2. The ground is paved – but many uneven areas
3. The cemetery is kind of hilly – if a tombstone is farther down the hill it will be very difficult for a wheelchair user to access it
4. Not much signage – no way to tell where you were or to find a tombstone. Add Braille.

5. Our recommendations are as follows:
- a. Our first recommendation is to repair the pavement inside the cemetery. Currently, there are some potholes and uneven spaces throughout the path. These can be a safety hazard that make it difficult to navigate the facility and inaccessible for wheelchair users. To meet the checklist criteria, the pavement must be stable, firm, and slip-resistant. While the existing path is slip-resistant and firm, it is not stable in lots of areas. This can be resolved by repaving this path and would be highly beneficial to all cemetery visitors. See picture #1.

- c. An additional recommendation would be to include an accessible restroom. There is currently no bathroom in the cemetery or in the vicinity of Woodside. The entrance to the bathroom must be level and wide, ensuring that each person is able

- d. A final recommendation is to build an accessible parking lot to prevent visitors from needing to park far from the cemetery. In creating a parking lot, it is important that there is an adequate number of accessible spaces and at least one van accessible space. Since there would likely be less than 25 spots in the lot given the minimal occupation of the cemetery at one period of time, only one accessible space would be necessary. However, more accessible spaces would be ideal considering that cemetery visitors are typically of the older population. Per the ADA Checklist, the accessible space must be at least 8 feet wide with a marked aisle that is at least 5 feet wide. Similarly, the van accessible space can be at least 11 feet wide with a marked aisle at least 5 feet wide. Finally, both accessible spaces should have clearly labeled signs and connect to the accessible sidewalks that lead to the entrance of the cemetery. Overall, parking that aligns with the ADA guidelines would increase the accessibility and public enjoyment of the cemetery.
